IBP Report 461

Long-term Performance of External Thermal Insulation Systems

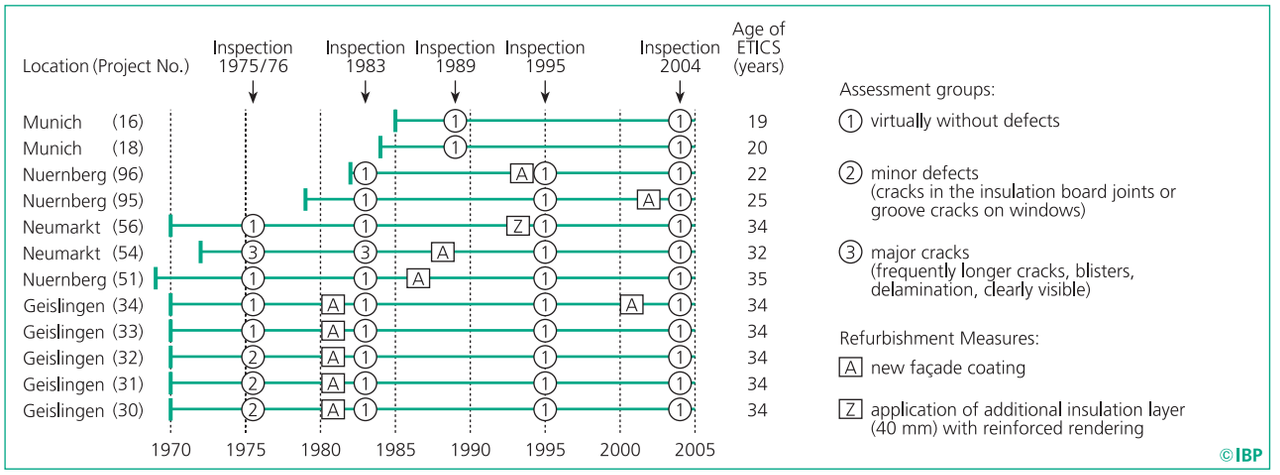
As was the case with previous investigations, the state of the investigated façade was classified according to three assessment groups. A survey on the investigated objects, the time periods of production, inspection and assessment of state is given in the diagram **(Fig.2)**, which also indicates the classification criteria.
The age of the investigated external thermal insulation composite systems (ETICS) is between 19 and 35 years. All ETICS, older than 20 years, were refurbished using one or two coatings. After the first inspection in 1975, half of the buildings had to be classified within the group 2 and 3 (minor or major defects) according to the diagram in Fig.2. After the latest inspection at the end of 2004, however, all buildings were assessed "without defect" (group1) after refurbishment. The refurbishment essentially consisted of applying new coatings, providing for a continuous improvement of the state of the façades over the years. This may result from the fact that in the early 1970s, the techniques to apply ETICS had yet to be optimized and the defects occurring were removed by refurbishment measures. The results of the assessment at the end of 2004 are as follows:

Fig. 2: Diagram of the time intervals between production, inspection and refurbishment of the ETICS in practice and classification of the state of the façade according to the assessment groups 1, 2 or 3.
